NASA TN D-1880

**EFFECT OF TWO BRAZE COATINGS,
PROCESSING VARIABLES, AND HEAT
TREATMENTS ON 1200° F STRESS-
RUPTURE STRENGTH OF L-605,
A-286, AND INCONEL 700 SHEET**

by John H. Sinclair and Charles A. Gyorgak

*Lewis Research Center
Cleveland, Ohio*

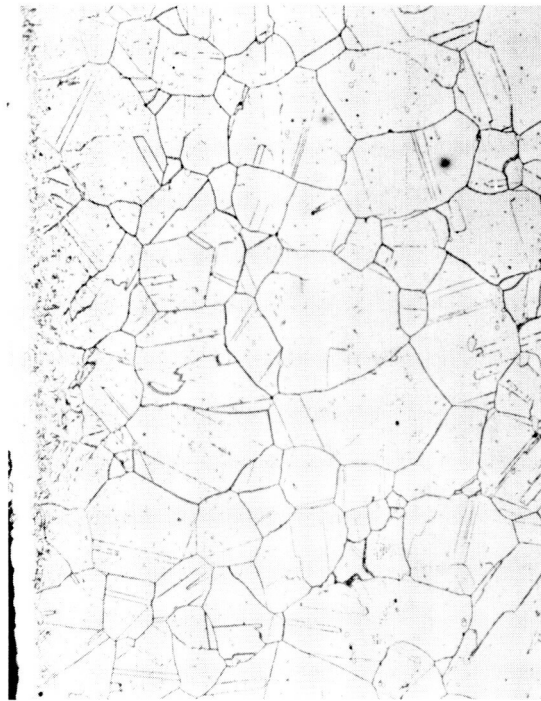
Figure 11. - Microstructures of L-605 stress-rupture specimens prior to testing. Electrolytically etched in a solution of 70 parts saturated boric acid in water, 30 parts 5 percent sulfuric acid solution. X250.

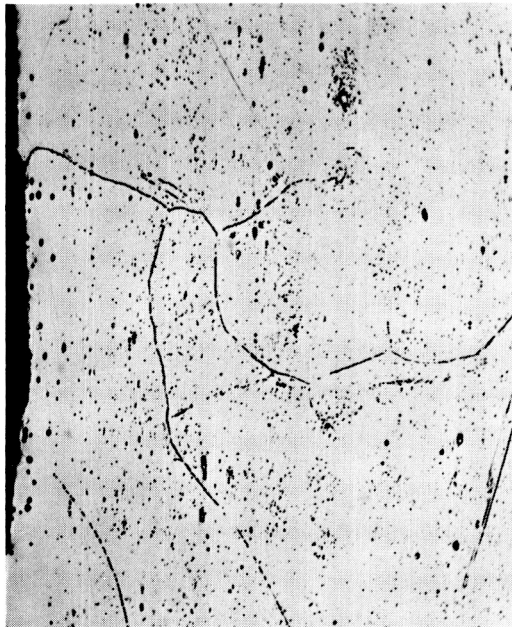
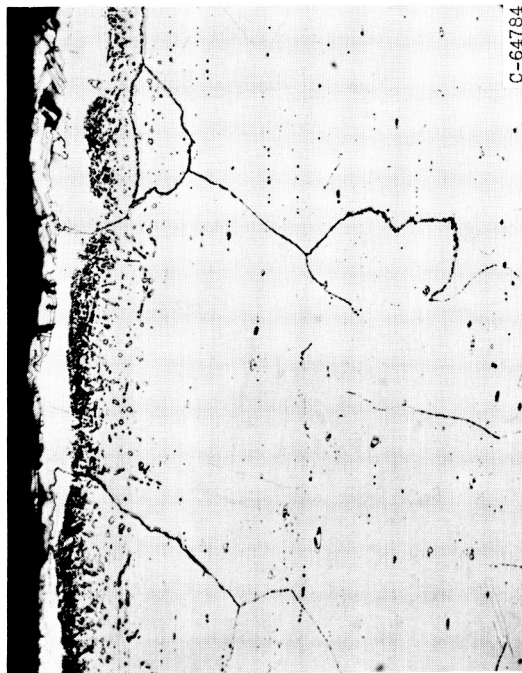
(a) Solution treated; operated 32.8 hours. Etched in glycerine - aqua regia.

(b) Solution treated and braze-temperature-cycled (2075° F) for 15 minutes; operated 3.5 hours. Etched in glycerine - aqua regia.

(c) Solution treated and NiCrSiB coated at 2075° F for 15 minutes. C-64784

Figure 12. - Microstructures of L-605 stress-rupture specimens. Solution treated at 2250° F for 30 minutes. Electrolytically etched in aqua regia in glycerine or solution of 70 parts saturated boric acid solution, 30 parts 5 percent sulfuric acid solution. X250.

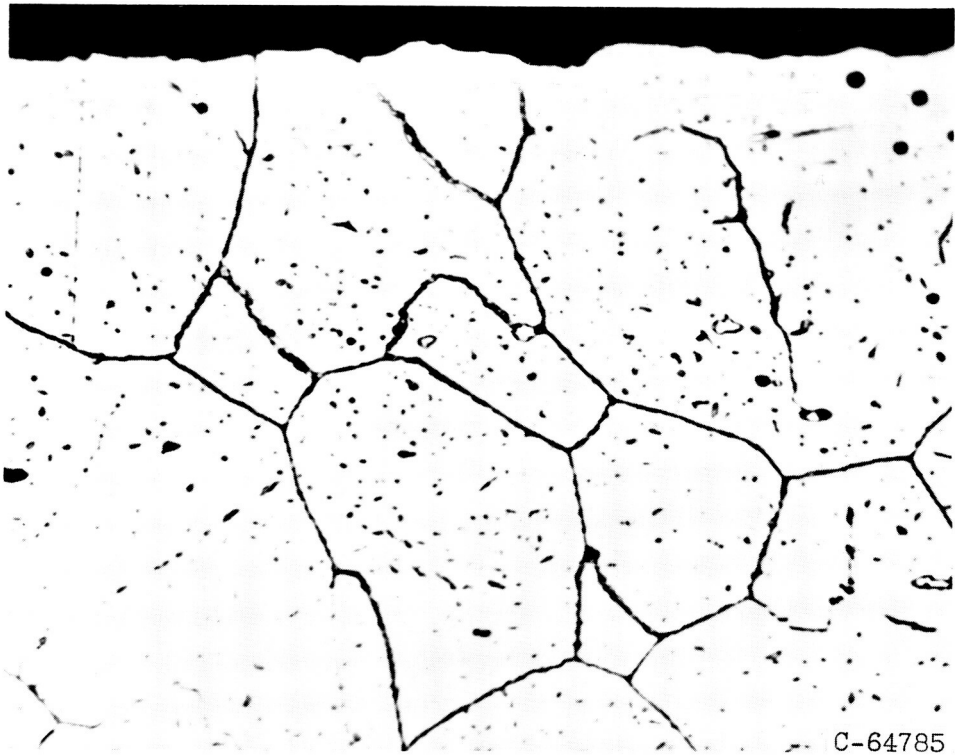
Figure 13. - Microstructure of L-605 stress-rupture specimen braze-temperature-cycled at 2150° F for 15 minutes; operated 3.8 hours. Electrolytically etched in solution of 70 parts saturated boric acid solution and 30 parts 5 percent sulfuric acid solution. X900.

Comparative photomicrographs of specimens braze-temperature-cycled at these two temperatures are given in figures 10(b) and 13. Even though the specimen in figure 13 had been stress-rupture tested 3.8 hours, no significant metallographic differences were noted.

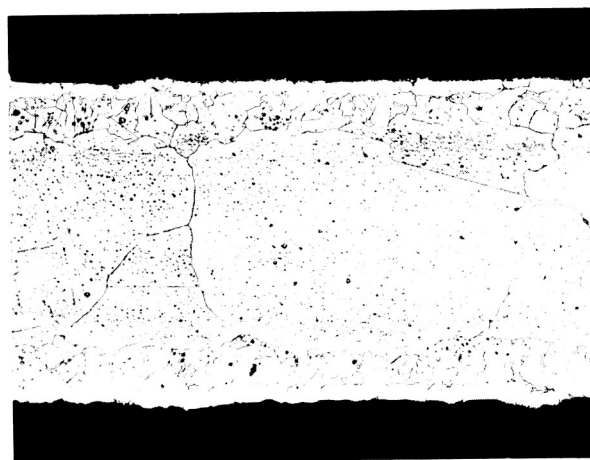
Figure 16. - Microstructures of A-286 stress-rupture specimens prior to testing. Electrolytically etched in a solution of 50 percent distilled water, 40 percent hydrochloric acid, and 10 percent nitric acid. $\times 100$.

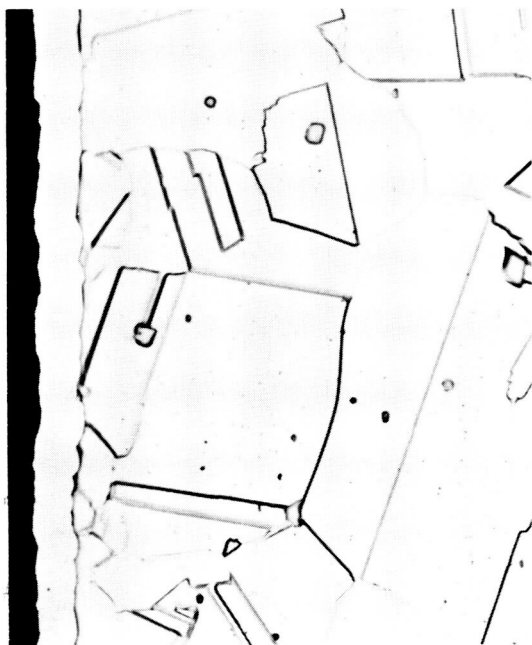
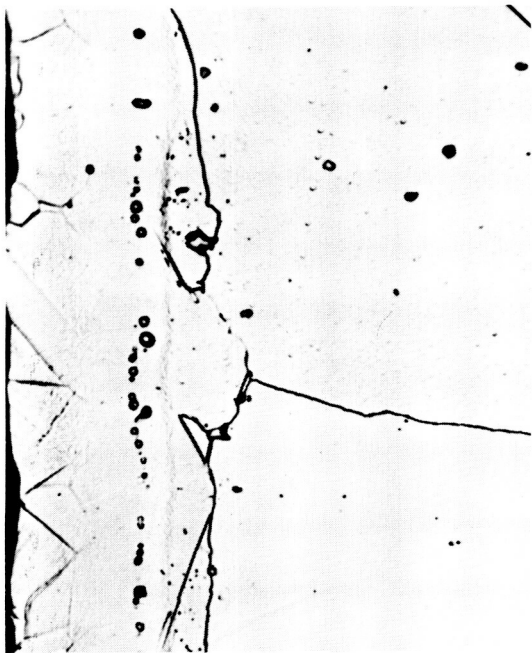
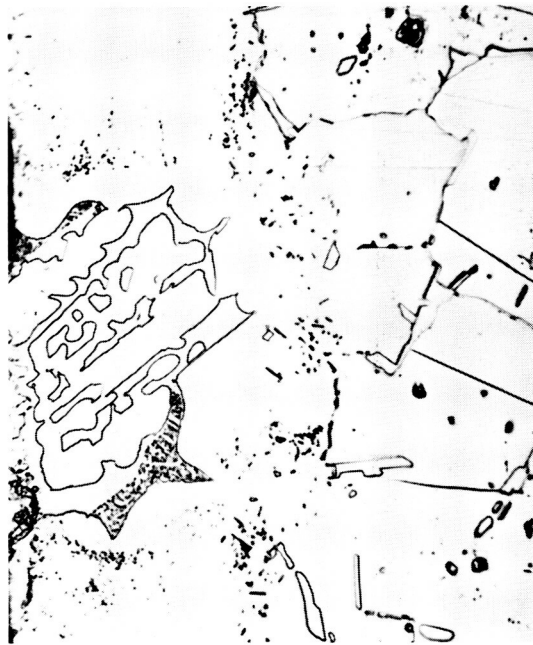
Figure 17. - Microstructures of A-286 stress-rupture specimens prior to testing. Electrolytically etched in a solution of 50 percent distilled water, 40 percent hydrochloric acid, and 10 percent nitric acid. X900.

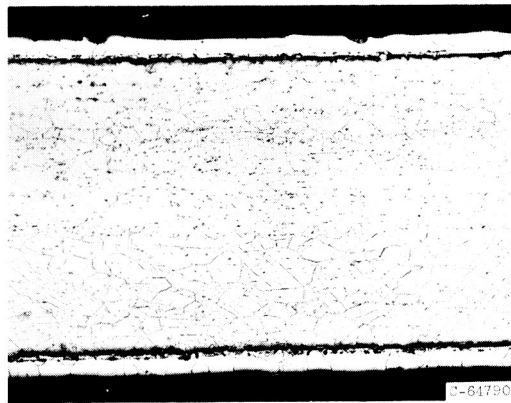
Figure 18. - Microstructures of Inconel 700 stress-rupture specimens prior to testing. Electrolytically etched in a solution of 50 percent distilled water, 40 percent hydrochloric acid, and 10 percent nitric acid unless otherwise noted. $\times 100$. Photographs reduced 39 percent.

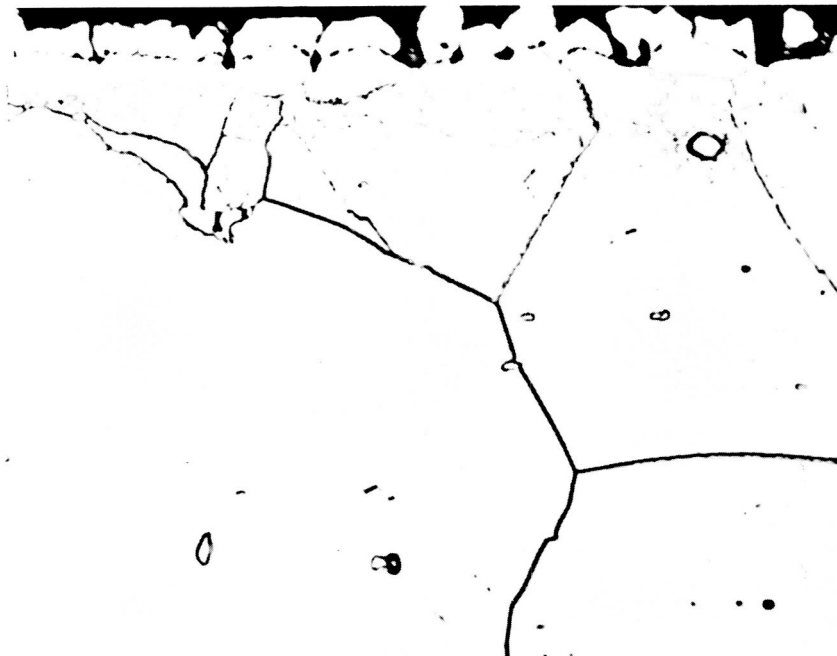
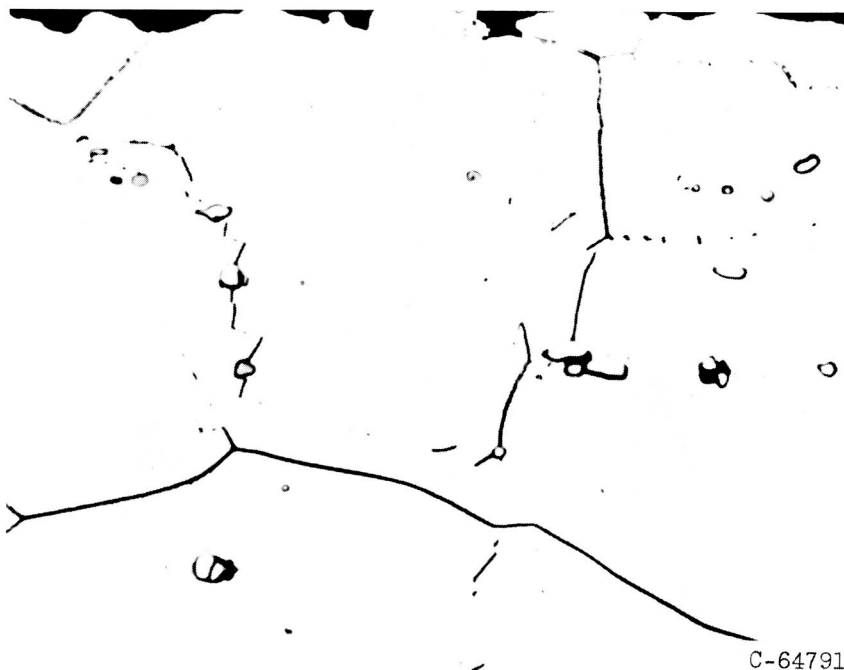
Figure 19. - Microstructures of Inconel 700 stress-rupture specimens prior to testing. Electrolytically etched in a solution of 20 parts glycerine, 20 parts water, 10 parts nitric acid, 5 parts hydrofluoric acid. $\times 900$. Photographs reduced 23 percent.
